USACERL Special Report 96/57 April 1996

Evaluation of Boiler Plant Energy Conservation Opportunities at Fort Hood, Texas

A Study for the Army Model Energy Installation Program

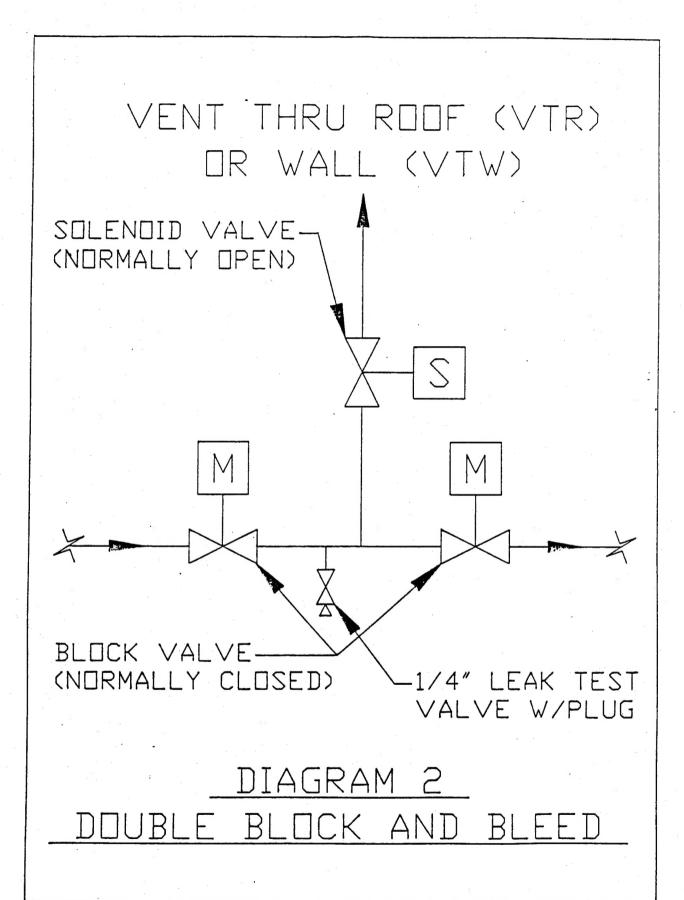
The second safety issue is the lack of double block and bleed valves on the boiler fuel gas train (See Appendix E, Diagram 2). The fuel gas train should have a block valve, then a bleed valve (which is a vent to the atmosphere), and then another block valve. In the event of a gas leak the bleed valve vents the natural gas to the outside, preventing an explosion. The cost to furnish and install the double block and bleed system is \$5,000.

The second safety issue is the lack of a bleed valve on the boiler fuel gas train (Appendix E, Diagram 2). The fuel gas trains have two block valves and no bleed valve (which is a vent to the atmosphere). In the event of a gas leak, the bleed valve vents natural gas to the outside, preventing an explosion. The cost to install a bleed valve is \$2,000.

The second safety issue is the lack of a bleed valve on the boiler fuel gas trains (Appendix E, Diagram 2). The fuel gas trains have two block valves but no bleed valve (which is a vent to the atmosphere). In the event of a gas leak, the bleed valve vents natural gas to the outside, preventing an explosion. The cost to install the bleed valve is \$2,000.

The third safety issue is the lack of a bleed valve on the boiler fuel gas train (Appendix E, Diagram 2). The fuel gas train has two block valves but no bleed valve (which is a vent to the atmosphere). In the event of a gas leak, the bleed valve vents natural gas to the outside, thus preventing an explosion. The cost to install a bleed valve is \$2,000.

The second safety issue is the lack of double block and bleed valves on the boiler fuel gas train (Appendix E, Diagram 2). The fuel gas train should have a block valve, then a bleed valve (which is a vent to the atmosphere), and then another block valve. In the event of a gas leak, the bleed valve vents the natural gas to the outside, preventing an explosion. The cost to install the double block and bleed system is \$5,000.

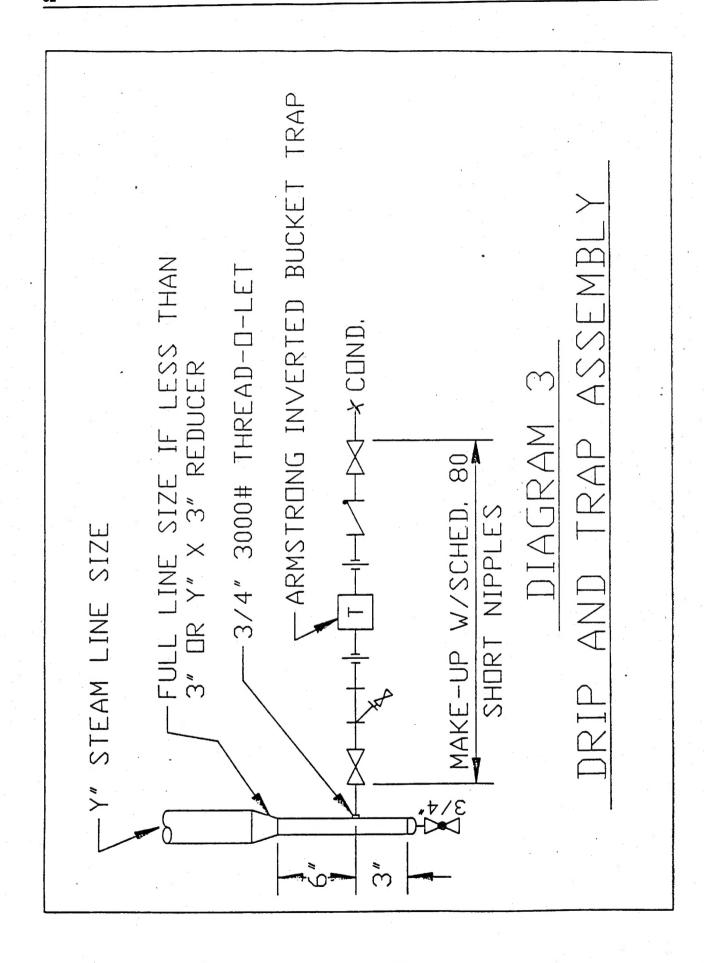
Finally, two condensate legs with trap assemblies are required on the main steam header (Appendix E, Diagram E3). This drip and trap assembly will remove condensate (formed because of heat loss to the environment) from the steam header. This condensate, if not removed, will cause water hammer, eventually leading to pipe fractures and support failures. This condensate should be returned to the condensate return tank. The cost to furnish and install the drip and trap assembly and associated valves, fittings, insulation, and piping is \$1,500. The condensate line from the steam header to each boiler should be removed.

Finally, two condensate legs with trap assemblies are required on the main steam header (See Appendix E, Diagram 3). This drip and trap assembly will remove condensate (formed because of heat loss to the environment) from the steam header. This condensate, if not removed, will cause water hammer, eventually leading to pipe fractures and support failures. This condensate should be returned to the condensate return tank. The cost to furnish and install the drip and trap assembly and associated valves, fittings, insulation, and piping is \$1,500. The condensate line from the steam header to each boiler should be removed.

Finally, two condensate legs with trap assemblies are required on the main steam header (Appendix E, Diagram 3). This drip and trap assembly will remove condensate (formed because of heat loss to the environment) from the steam header. This condensate, if not removed, will cause water hammer, eventually leading to possible pipe fractures and support failures. This condensate should be returned to the condensate return tank. The cost to furnish and install the drip and trap assembly and associated valves, fittings, insulation, and piping is \$1,500. The condensate line from the steam header to each boiler should be removed.

Finally, two condensate legs with trap assemblies are required on the main steam header (Appendix E, Diagram 3). This drip and trap assembly will remove condensate (formed because of heat loss to the environment) from the steam header. This condensate, if not removed, will cause water hammer, eventually leading to pipe fractures and support failures. This condensate should be returned to the condensate return tank. The cost to furnish and install the drip and trap assembly and associated valves, fittings, insulation, and piping is \$1,500. The condensate line from the steam header to each boiler should be removed.

Finally, another drip and trap assembly needs to be installed in the steam header (Appendix E, Diagram 3). Two drip and trap assemblies are required in case one should fail. The condensate should go back to the condensate return tank. The cost to furnish and install a drip and trap assembly is \$1,000.
